UNDERWATER BRIDGE INSPECTION REPORT

STRUCTURE NO. 8520

MINNESOTA RIVER

DISTRICT 7 - BROWN COUNTY, CITY OF NEW ULM

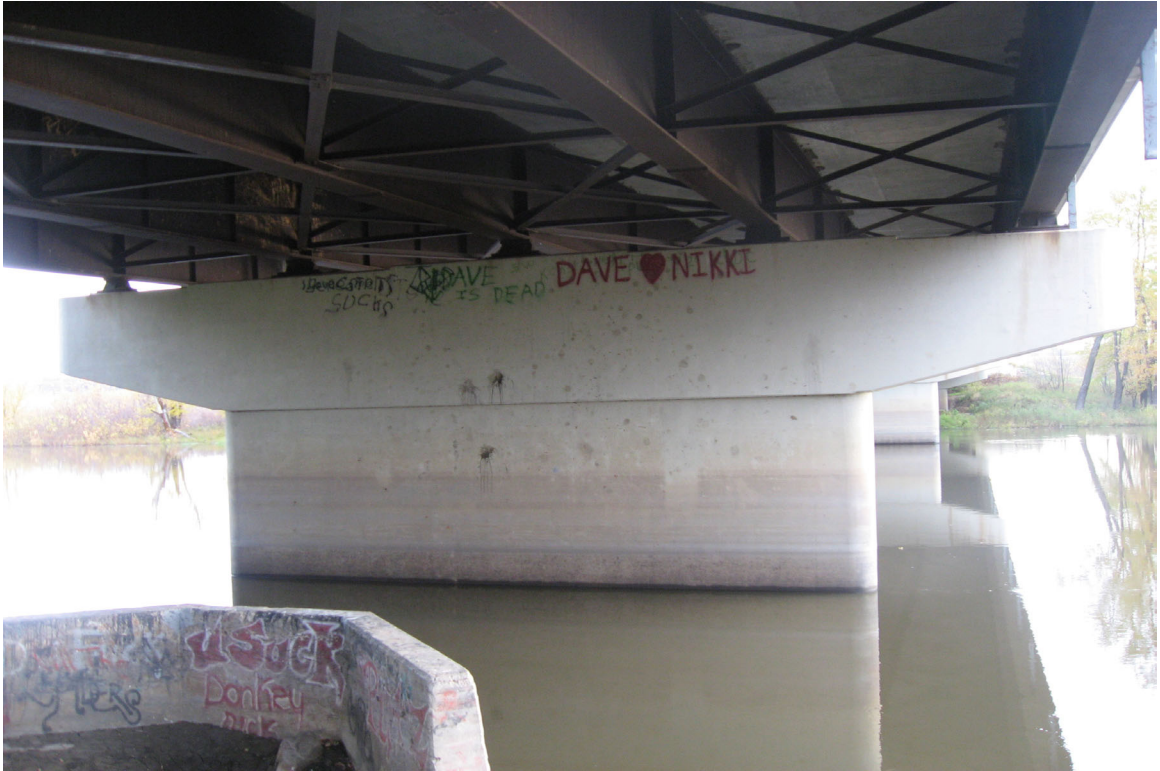
- (A) A moderate accumulation of timber debris, which included pieces up to 12 inches in diameter, was observed from the channel bottom to 5 feet above the channel bottom at the upstream nose and extending along both faces of Pier 1 to the upstream quarter points of the shaft.
- (B) The top of the footing was exposed at Pier 1 from the upstream quarter point on the west face, around the upstream nose, and along the entire east face with up to 4 feet of vertical face exposure along the east face.
- (C) Pier 3 exhibited footing exposure around the majority of the pier with up to 1.5 feet of vertical face exposure due to a scour depression 10 feet in radius within the easterly bank.
- (D) A scour depression 6 feet in radius, 2 feet deep was observed at the upstream noses of Piers 1 and 2.

Photograph 1. View of Pier 1, Looking Northeast.

- (A) Monitor the timber debris at Pier 1, and if found to be increasing in the future, removal operations may become warranted.
- (B) Because the bridge has been evaluated to be scour critical, monitor the pier footing exposures and the extent of scour during high flows and also during future inspections, and if found to be increasing, countermeasures may become warranted.
- (C) Reinspect the submerged substructure units at the normal maximum recommended (NBIS) interval of five (5) years unless a period of high flow creates the need for a sooner inspection.

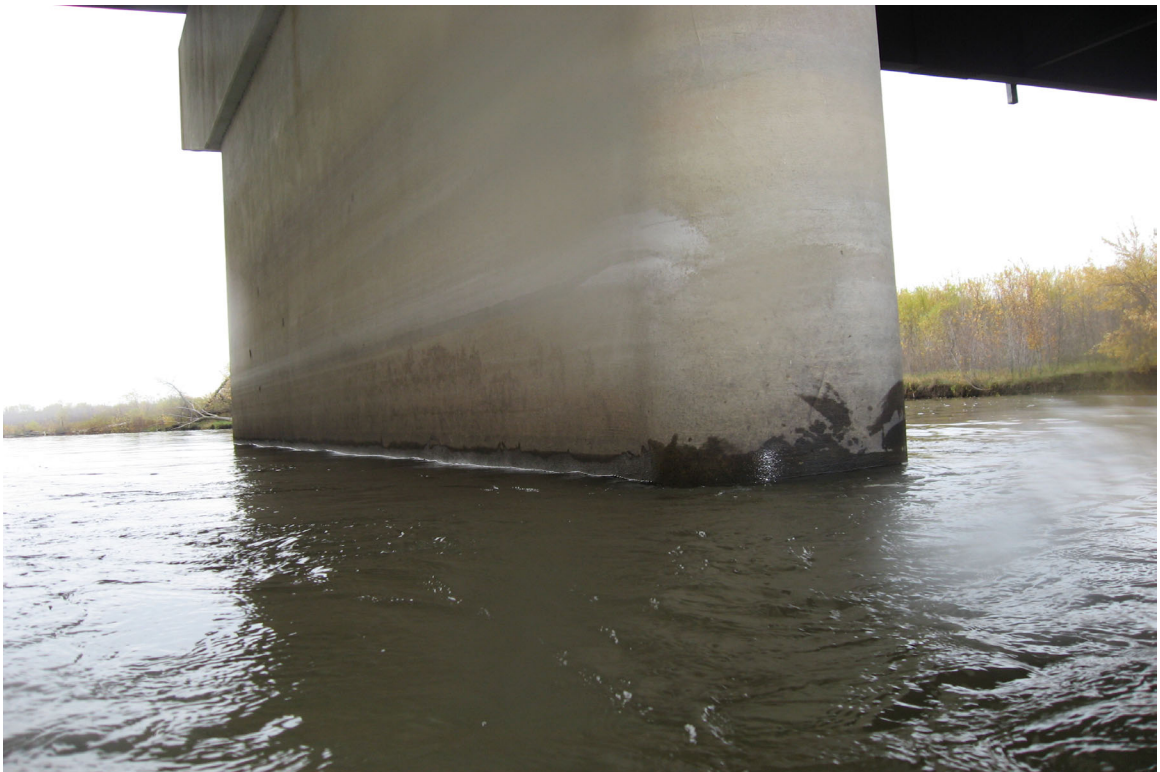
Photograph 2. View of Pier 2, Looking Southeast.

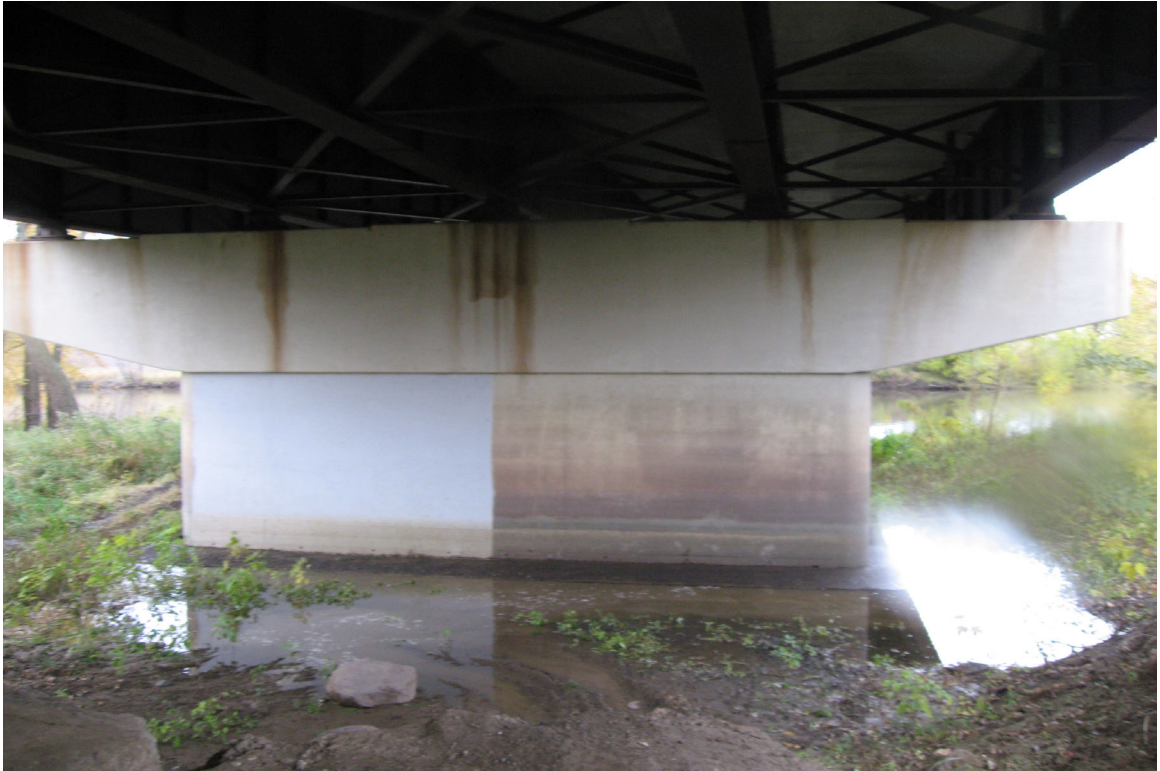
Photograph 3. View of Pier 3, Looking Southwest.

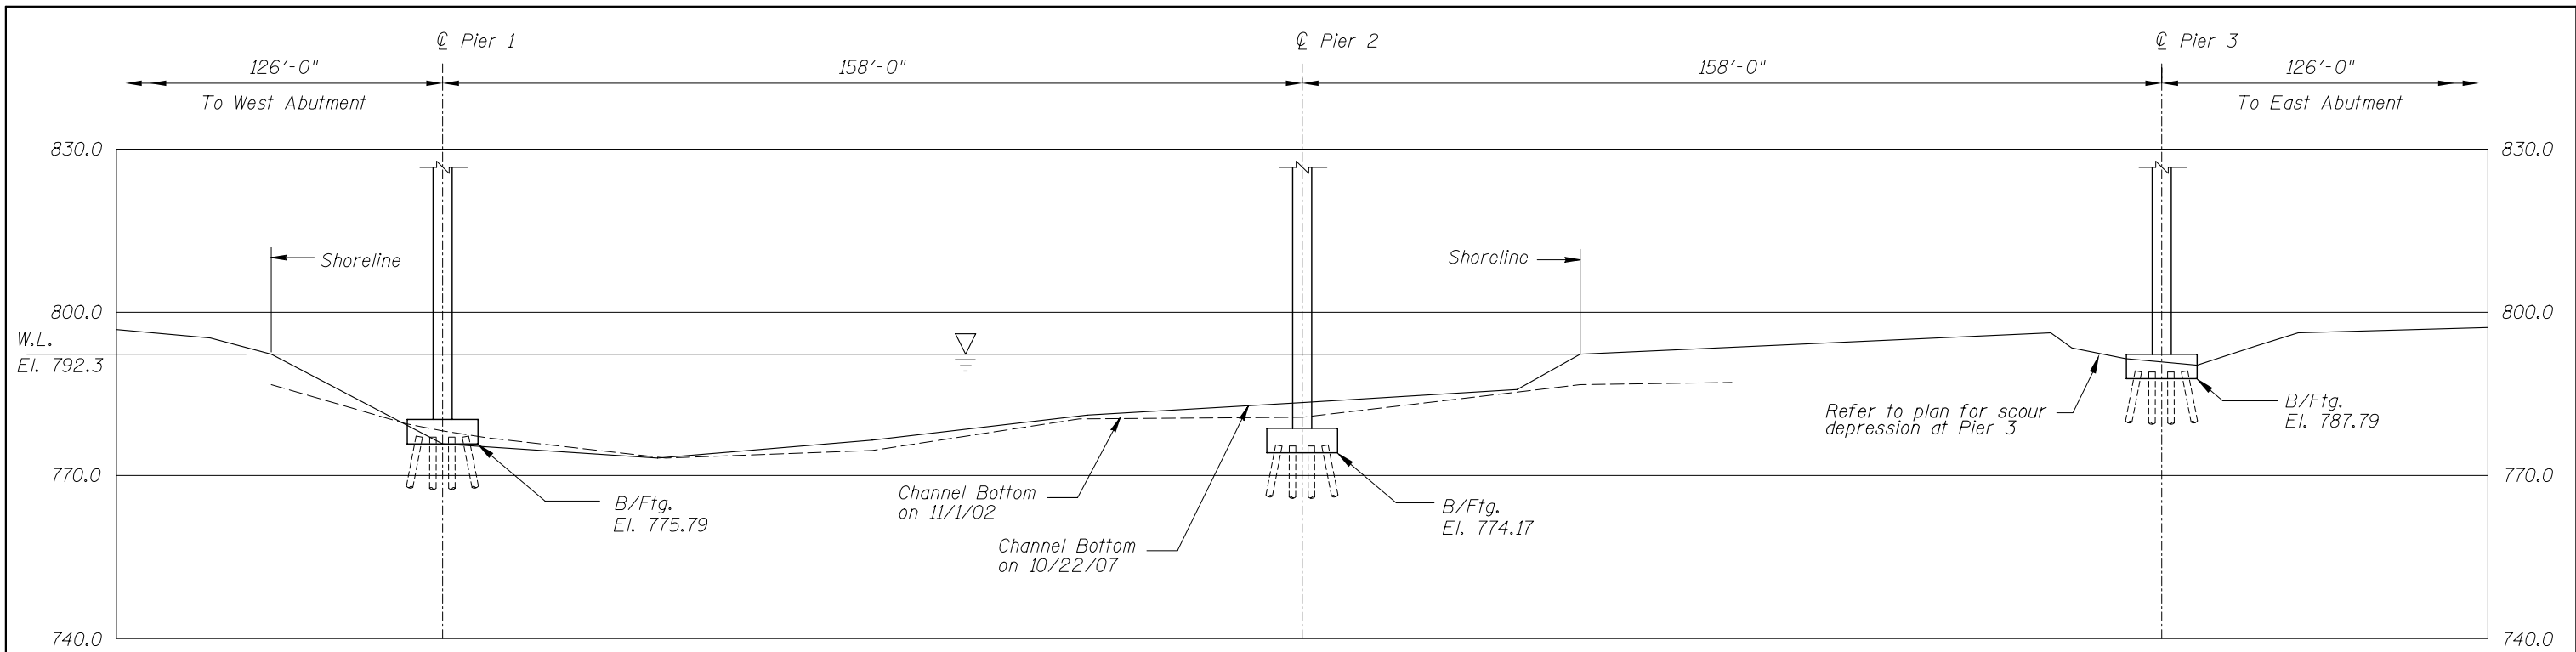
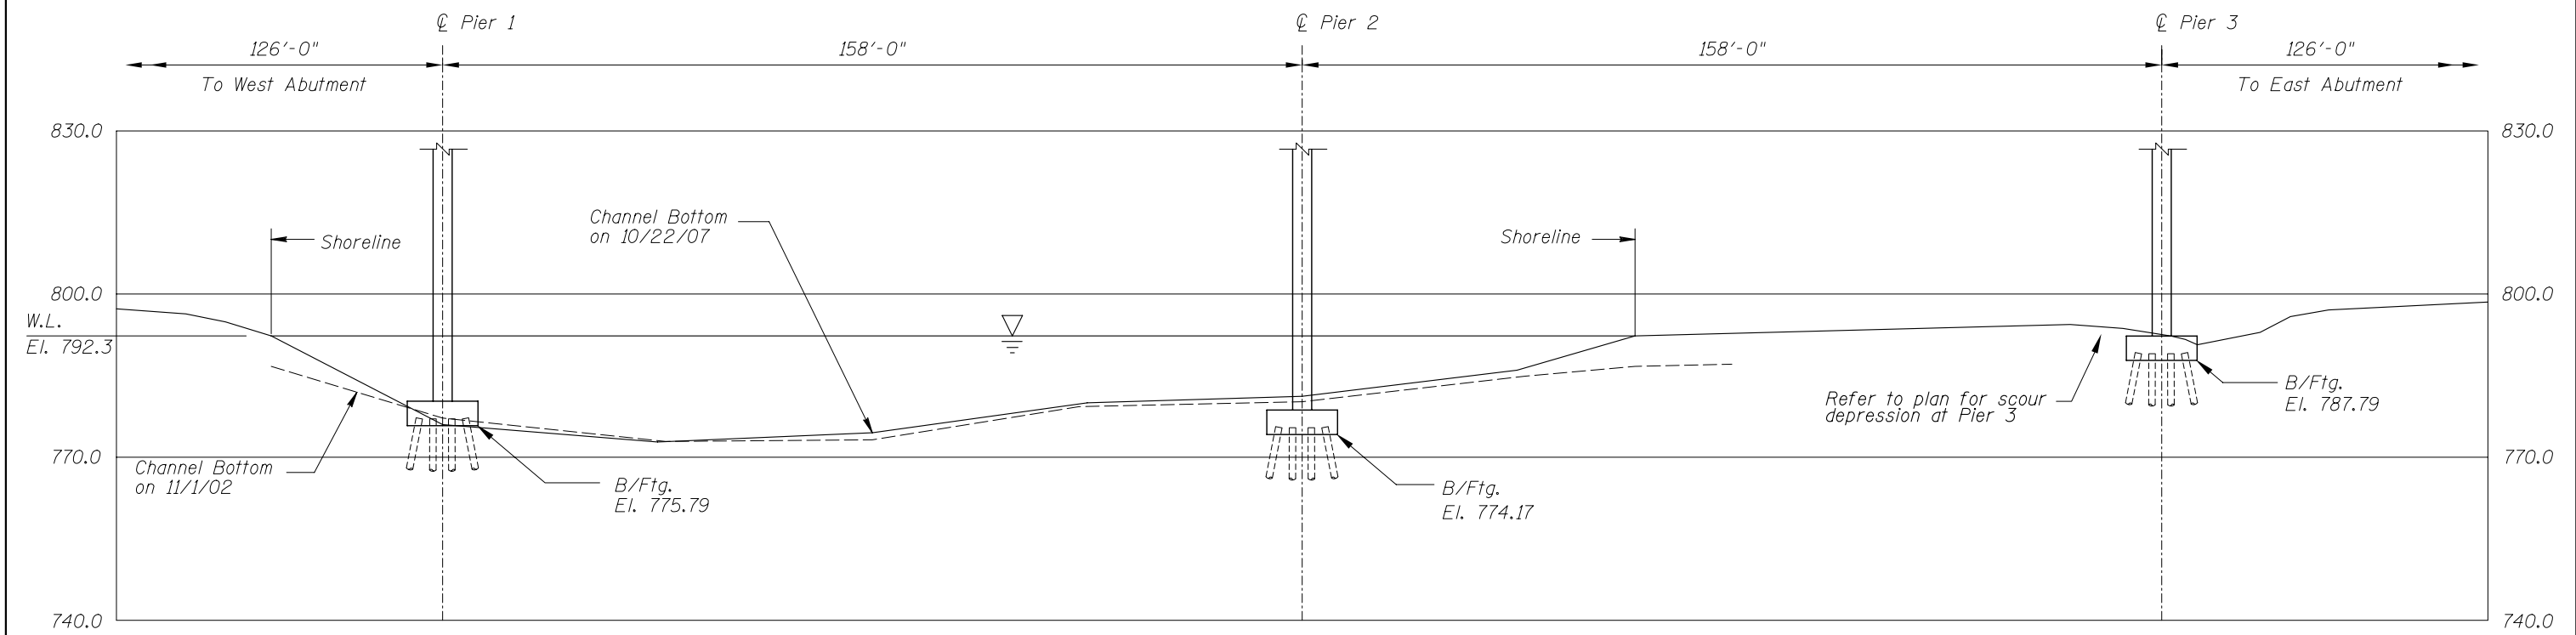
UPSTREAM FASCIA PROFILE

DOWNSTREAM FASCIA PROFILE
